**TECHNICAL REPORT HL-84-12**

## NAVIGATION CONDITIONS AT MITCHELL LOCK AND DAM COOSA RIVER, ALABAMA

Hydraulic Model Investigation

Carolyn M. Myrick Hydraulics Laboratory

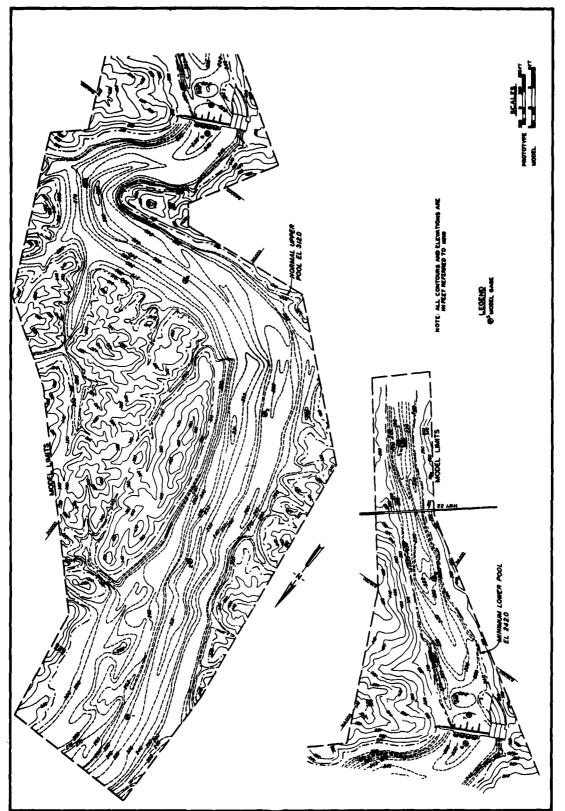
Figure 2. Base conditions

- 9. The model (Figure 2) reproduced about 4 miles of the Coosa River channel, Mitchell Lake, and the adjacent overbank areas from about 14,500 ft above and 6,500 ft below Mitchell Dam. The model was of the fixed-bed type with the channel and overbank areas molded in sand-cement mortar to sheet-metal templates. Portions of the model, where changes in lock alignments and channel configurations were considered or could be anticipated, were molded in pea gravel to allow for easy modification. The lock, dam crest, piers, powerhouse, and guard walls were built from sheet metal. The dam gates were simulated schematically with simple sheet-metal slide-type gates. The powerhouse units were connected to a pumping system and flowmeters which could be operated to reproduce variations in powerhouse releases.

14. The model surface was constructed of brushed cement mortar to provide a roughness (Manning's n) of about 0.0135 which corresponds to a prototype roughness of about 0.030. With the existing dam and powerhouse in place, the model was checked against limited prototype data which consisted mostly of current directions and velocities with low flow conditions. Results indicated that the model reproduced the existing prototype conditions with a reasonable degree of accuracy.

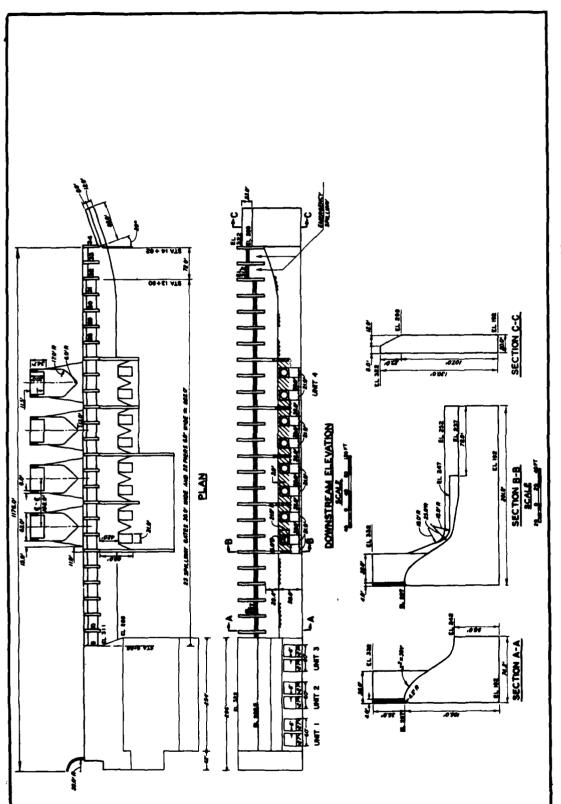
Figure 3. Base conditions, powerhouse and spillway

- 19. Base tests were conducted with the redeveloped Mitchell powerhouse in operation. The purpose of these tests was to provide information and data that could be used in determining the effects of the proposed modifications on water-surface elevations and current directions and velocities before the lock was installed on the model. The principal features shown in Figures 2 and 3 include:
  - a. A nonnavigable gated spillway with 23 tainter gates 30 ft wide by 15 ft high with the crest el 297.0.
  - b. Two fixed crests bays 30 ft wide with crest el 312.0 and an overflow section 88 ft wide with crest el 322.0.
  - c. The redeveloped power plant with the new three-unit powerhouse on the right bank and one existing unit in operation.
  - d. The Alabama Highway No. 22 Bridge.

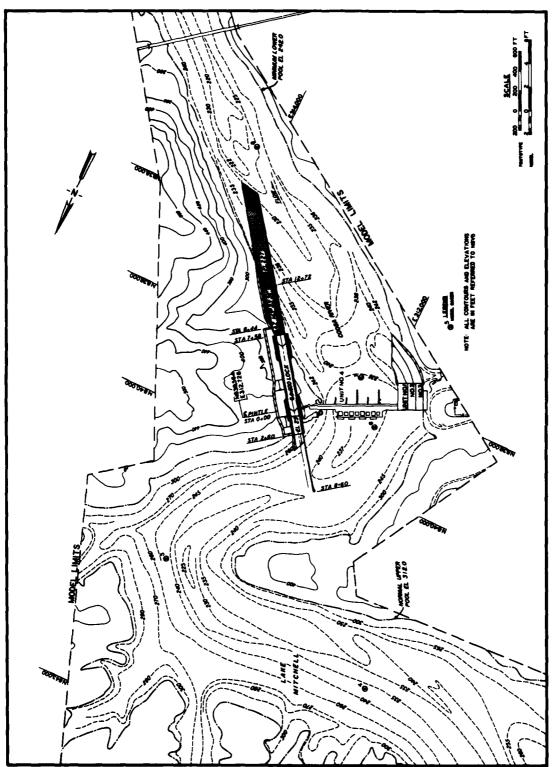
Figure 4. Plan A

22. Plan A involved the construction of a navigation lock at Mitchell

Dam on the first proposed alignment adjacent to the dam. The additional principal features include (Figures 4 and 5):

- 25. Navigation conditions in the upper lock approach would be difficult at low flows and hazardous at high flows. With all flows, downbound tows would approach the upstream guard wall at a steep angle due to the alignment of the guard wall with respect to the river channel and would experience difficulty aligning with and laying against the guard wall. With flows of 90,000 cfs and above, downbound tows were in danger of being slammed against the guard wall with considerable force by the high-velocity currents approaching the wall. Upbound tows would have difficulty breaking free of the guard wall and would have to rotate the head of the tow about 45 to 60 deg before they could maneuver off the wall. Upbound tows with the ability to maneuver off the upstream guard wall could navigate through the reach with no additional problems.

- 26. In the lower pool, tows would have no problems entering or leaving the lock approach. However, upbound tows would have to overcome extremely high-velocity currents in the approach to the lock at medium to high flows. Upbound tows with sufficient power to maintain headway and steerage could approach the lock without any major problems. However, navigation conditions at the Highway 22 Bridge could be hazardous at medium to high flows due to the limited clearance provided at the bridge with the existing piers and low superstructure and the high-velocity currents for both upbound and downbound tows.

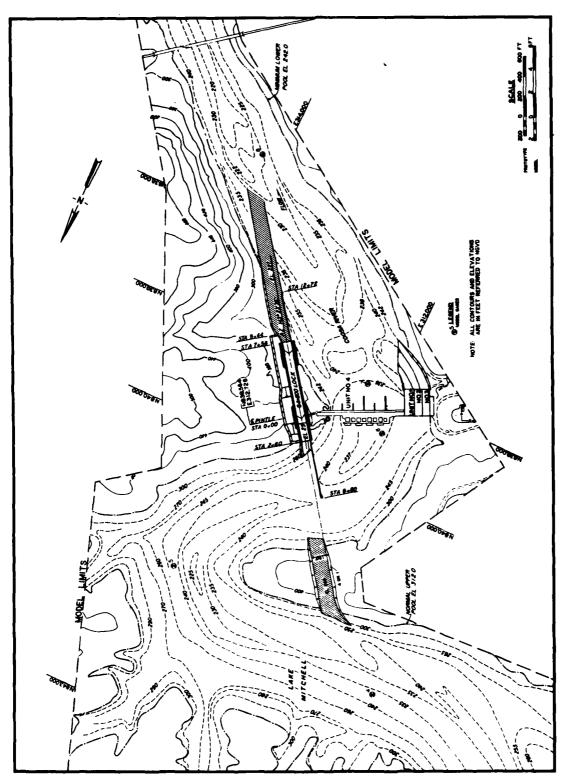
Figure 6. Plan A-1

27. Plan A-1 was the same as Plan A except that in the upper pool (Figure 6) a 150-ft-wide canal with bottom el 285.0 was excavated through the point on the right overbank upstream of the lock as proposed by the District. There were no changes downstream of the dam.

- 28. Water-surface elevations shown in Table 3 were unchanged from Plan A.
- 29. Current directions and velocities shown in Plate 8 indicate maximum velocities through the canal ranging from 0.7 to 5.7 fps. Alignment and velocities of currents approaching the upper guard wall were not significantly changed compared with Plan A. Currents adverse to navigation would tend to develop between the end of the upper guard wall and the canal entrance with maximum velocities ranging from 0.4 to 4.5 fps.

- 30. At the 35,000-cfs flow, a tow could enter and leave the upper lock approach through the canal with no problems. However, with the 90,000- and 175,000-cfs flows, a downbound tow entering the canal would tend to be grounded along the left bank line of the caral. A downbound tow navigating between the canal and the lock would encounter strong crosscurrents and would tend to be moved downstream of the lock approach. Navigation conditions with this plan could be hazardous particularly with the high flows. Tows could be moved from the lock approach and onto the gated dam or downbound tows could strike the upper end of the guard wall and break loose from the tow. An upbound tow encountering the crosscurrents as it cleared the end of the guard wall would be pushed downstream causing it to be pushed aground on the right bank of the canal.

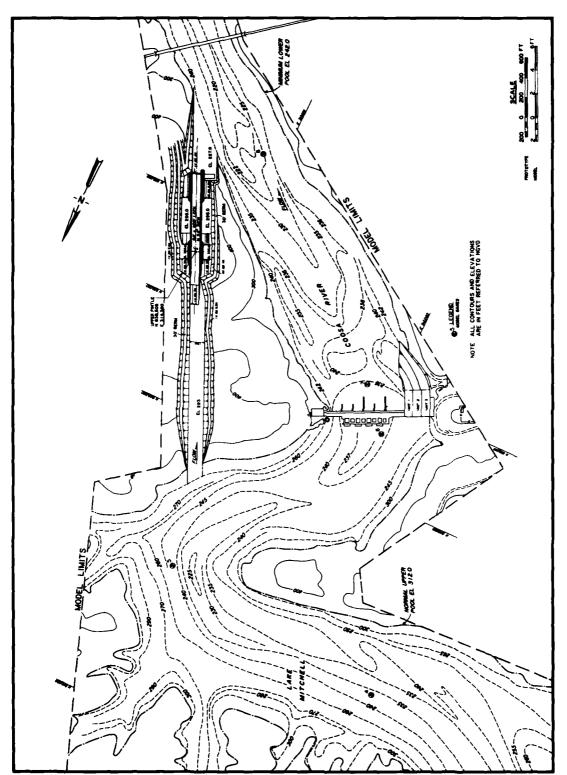
Figure 7. Plan B

- 31. Plan B involved locating the navigation lock on the second proposed alignment in a canal in the left overbank area and redeveloping the Mitchell spillway. Modifications (Figures 7 and 8) included:
  - a. The lock located in a 150-ft-wide canal with bottom el 293.0, a 400-ft upper guide wall, and a 514-ft lower guide wall.

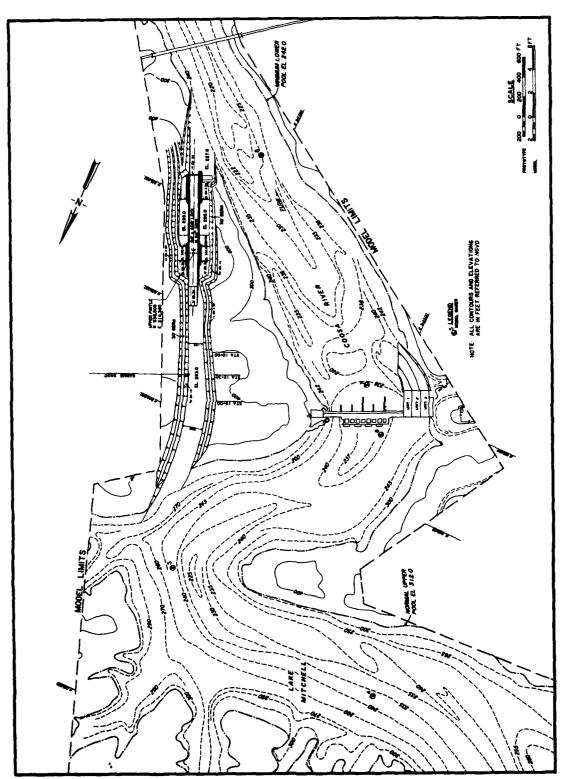
Figure 9. Plan B-1

- a. Plan B-1. The entrance to the lock canal was widened to 200 ft and aligned on a 2,600-ft radius curved toward the left bank (Figure 9).
- b. Plan B-2. The entrance to the lock canal was flared on a 15-deg angle (Figure 10) to reduce excavation required.
- c. Plan B-3. A 420-ft-long dike with top el 314.0 and side slopes of 1V on 1.5H was added just downstream of the entrance to the lock canal (Figure 11) to eliminate navigation problems at high flows.

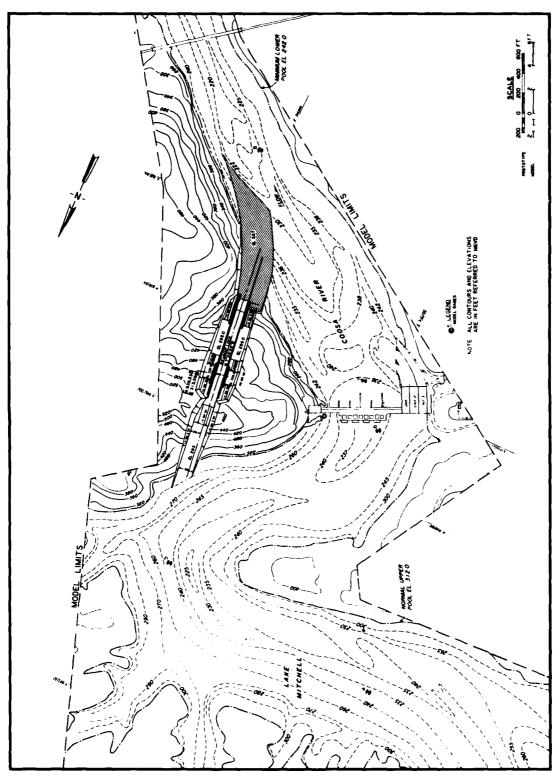
Figure 12. Plan C

- 42. Plan C involved realigning the lock to improve navigation conditions in the lower approach (Figure 12). Features were the same as Plan B except that the lock was rotated in the left overbank and the lower entrance to the lock canal was moved upstream about 1,700 ft providing a longer maneuvering distance between the bridge and the lock canal and reducing excavation in the lower approach. The lower guard wall was moved to the riverside of the lock to prevent the tow from being pinned against the wall by the currents. Results

- 44. Current directions and velocities shown in Plates 16-21 indicate little change in the upper pool from base conditions. The entrance to the upper lock canal aligned with the slow currents along the left bank. In the lower pool at the 15,000- and 35,000-cfs flows there was turbulence at the end of the guard wall and an eddy developed in the lower approach. For higher flows evenly distributed through the gated dam the turbulence decreased. With the 65,000-cfs flow distributed through the powerhouse and the five adjacent gates only, the currents became turbulent at the end of the guard wall and erratic at the bridge. Maximum velocities at the bridge ranged from 3.3 fps for the 35,000-cfs flow to 14.3 fps for the 175,000-cfs flow.

- 45. In the upper pool, satisfactory navigation conditions were developed with all flows tested. Upbound tows leaving the lock canal could navigate upstream with no problems. Downbound tows could align with and enter the lock canal from near midchannel to the left bank provided the tow avoids the eddy

on the extreme left bank just upstream of the canal entrance. The eddy presented no danger to the tow but would require maneuvering for the tow to align with and enter the canal.

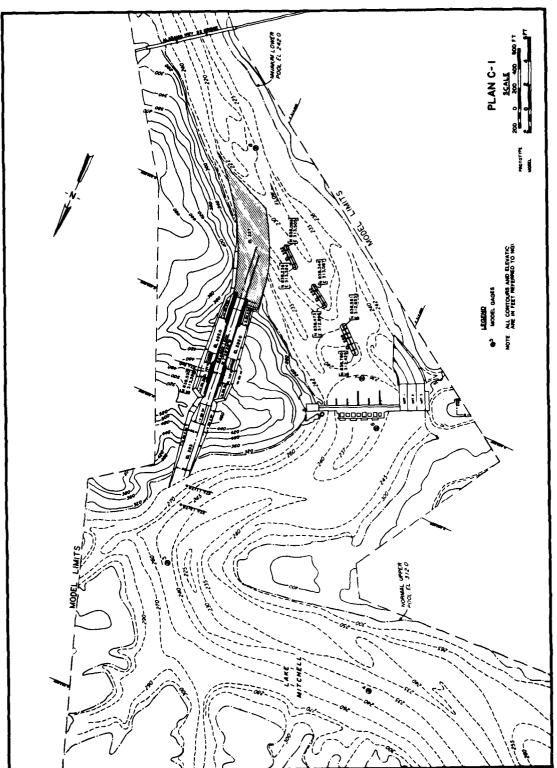
Figure 13. Plan C-1

47. Plan C-1 was the same as Plan C except that three vane dikes were added upstream of the lower guard wall to straighten the currents and reduce velocities in the lower lock approach and two 20-ft-diam protection cells were placed in the upper pool aligned with the right bank of the lock canal (Figure 13). Dike 1 was 300 ft long with top el 259.0. Dikes 2 and 3 were 230 ft long with top el 252.0.

- 48. Water-surface elevations shown in Table 9 indicate an increase in the lower pool of about 0.1 ft over Plan C.
- 49. Current directions and velocities shown in Plates 22-24 indicate that the vane dikes reduced velocities in the lower lock approach and reduced the velocity of the eddy in the lock canal. The turbulence at the end of the guard wall for low flows and the 65,000-cfs flow unevenly distributed through the gated dam was reduced. The dikes also stabilized the erratic currents at the bridge caused by the flow unevenly distributed through the dam.
- 50. In the upper pool, navigation conditions were relatively unchanged from Plan C. The protection cells were not required for navigation but

provided a factor of safety, giving a tow something to align with and to land on if needed.

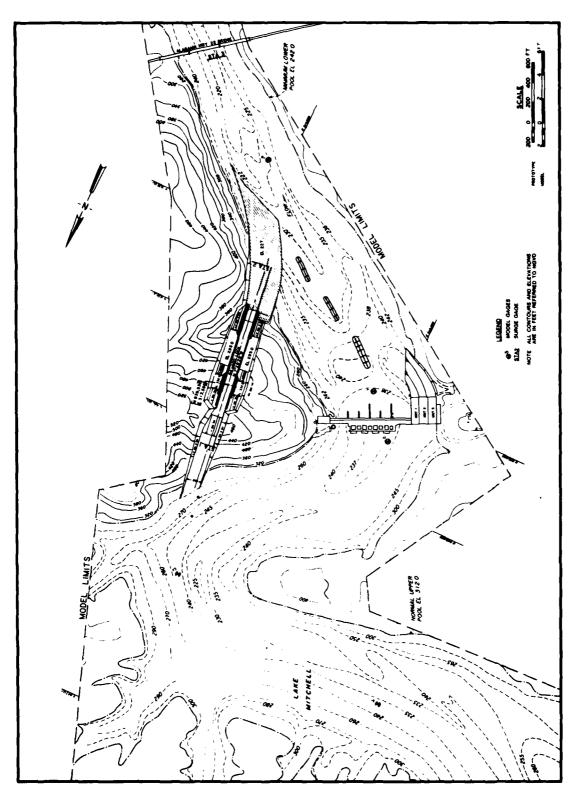
Figure 14. Location of surge stations

- 52. Surges created by lock filling and emptying and the start of power-house releases may seriously affect navigation. Surge data were taken at three stations with Plan C-1. Sta 1, 2, and 3 were located about 650 ft upstream, 1,250 ft downstream, and 3,400 ft downstream of the upper lock pintle, respectively (Figure 14). Results of these tests with the lock filling and emptying in 10 min and instantaneous powerhouse releases are shown in Plates 25-31.

<sup>\*</sup> Locations of surge stations are shown in Figure 14.
